# Manhole Inspection Summary

Manhole # S29UU\_005MH

Insp Date: **5/16/07 9:10 AM**

**Location** Address: **2902 KESWICK RD**

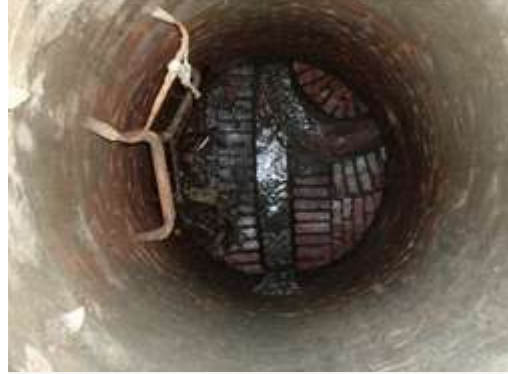
Top View

Corroded and missing steps. Bench debris.

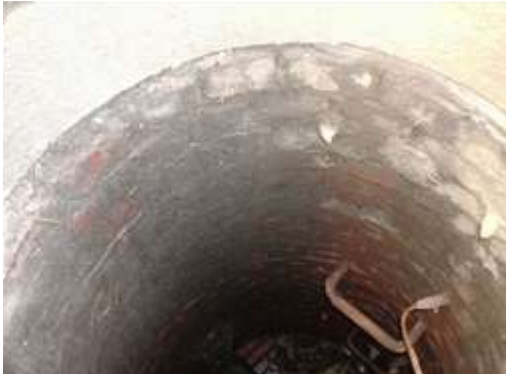
Defect

Frame leaks. Adjustment deterioration and infiltration. Corbel infiltration - other side.

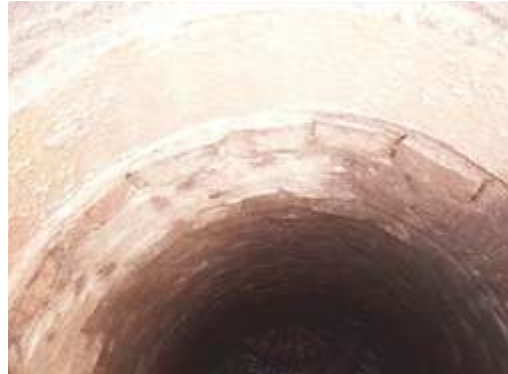
Defect

Frame leaks. Adjustment deterioration and infiltration. Corbel infiltration.

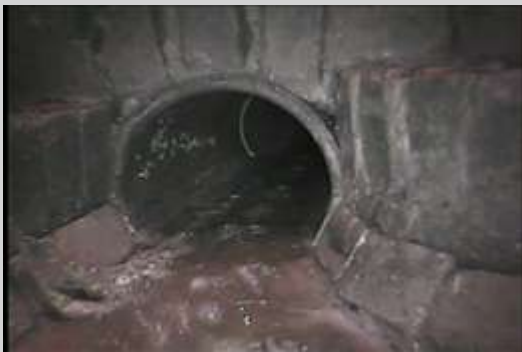
### 8 in. Circular Gravity Sewer Pipe Out @ 12 O'Clock

Infiltration: **Evidence** Pipe Seal Cond: **Cracked**

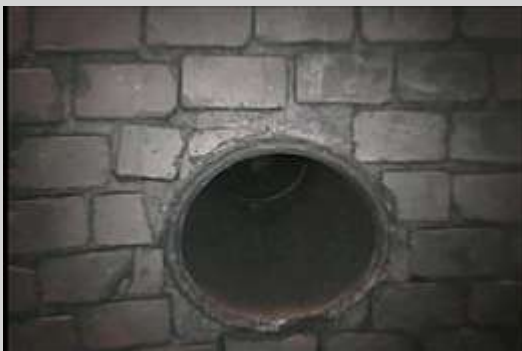
### 8 in. Circular Gravity Sewer Pipe In @ 3 O'Clock

Infiltration: **Evidence** Pipe Seal Cond: **Unknown**

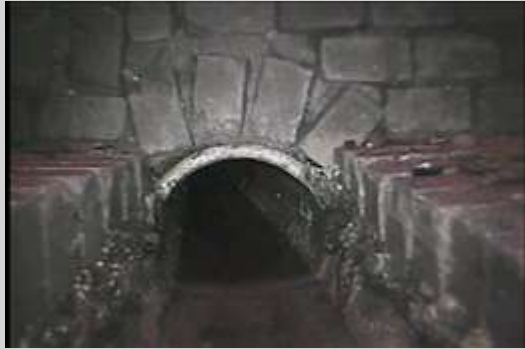
Pipe In @ 6 O'Clock

Barrel infiltration. Channel grease deposits.

Deposits: ☐ None ☐ Mud ☐ Sludge ☐ Debris ☒ **Grease**

Deposits Extent: **Light**

Infiltration: **Evidence**
